Incident Summary Page for the 100 Fires Project

Incident Name: Decker Fire	Incident Date & Time: 08/08/1959 @ 18:00
Incident Location: Ortega Highway, 3 miles west of Lake Elsinore Village, Riverside County, California	Incident Size: Approximately 5 acres at initial attack 1391 acres final size
Types of resources involved: US Forest Service Hotshot Crew, tankers, and district personnel California Division of Forestry tankers and inmate crew	# of Fatalities/injuries: 6 fatalities / 12+ injuries Unable to verify exact number of injuries from investigation report
Reasons this fire was selected for the 100 Fires list:	
<ul style="list-style-type: none"> ➤ Fire is historically significant ➤ 3 or more firefighter fatalities by entrapment 	
Conditions leading up to the event:	
<p>On the day of the incident, a group of teenagers were partying in a campground on the Cleveland National Forest. In the late afternoon, a fight broke out and two of the partiers decided to leave. They headed east on the Ortega Highway towards Elsinore. They lost control of their pick-up on a steep, twisting section of the highway and plunged 200 feet over an embankment and burst into flames, igniting the tinder

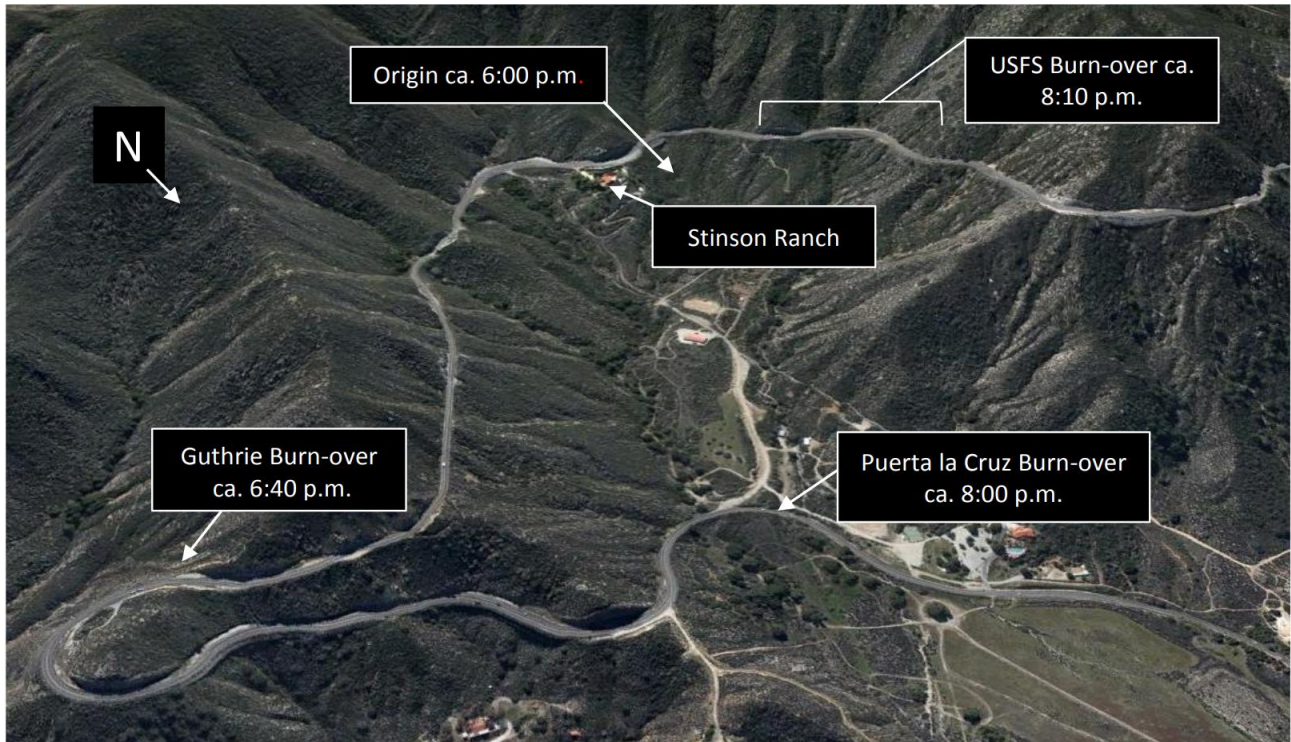
Figure 2. Google Earth satellite image of the mouth of Decker Canyon showing approximate location and timing of the fire's origin and the three burn-over events.
