Incident Summary Page for the 100 Fires Project

Incident Name: Decker Fire	Incident Date & Time: 08/08/1959 @ 18:00
Incident Location: Ortega Highway, 3 miles west of Lake Elsinore Village, Riverside County, California	Incident Size: Approximately 5 acres at initial attack 1391 acres final size
Types of resources involved: US Forest Service Hotshot Crew, tankers, and district personnel California Division of Forestry tankers and inmate crew	# of Fatalities/injuries: 6 fatalities / 12+ injuries Unable to verify exact number of injuries from investigation report
Reasons this fire was selected for the 100 Fires list:	
<ul style="list-style-type: none"> ➤ Fire is historically significant ➤ 3 or more firefighter fatalities ➤ Hotshot line of duty death 	
Conditions leading up to the event:	
<p>On the day of the incident, a group of teenagers were partying in a campground on the Cleveland National Forest. In the late afternoon, a fight broke out and two of the partiers decided to leave. They headed east on the Ortega Highway towards Elsinore. They lost control of their pick-up on a steep, twisting section of the highway and plunged 200 feet over an embankment and burst into flames, ignit

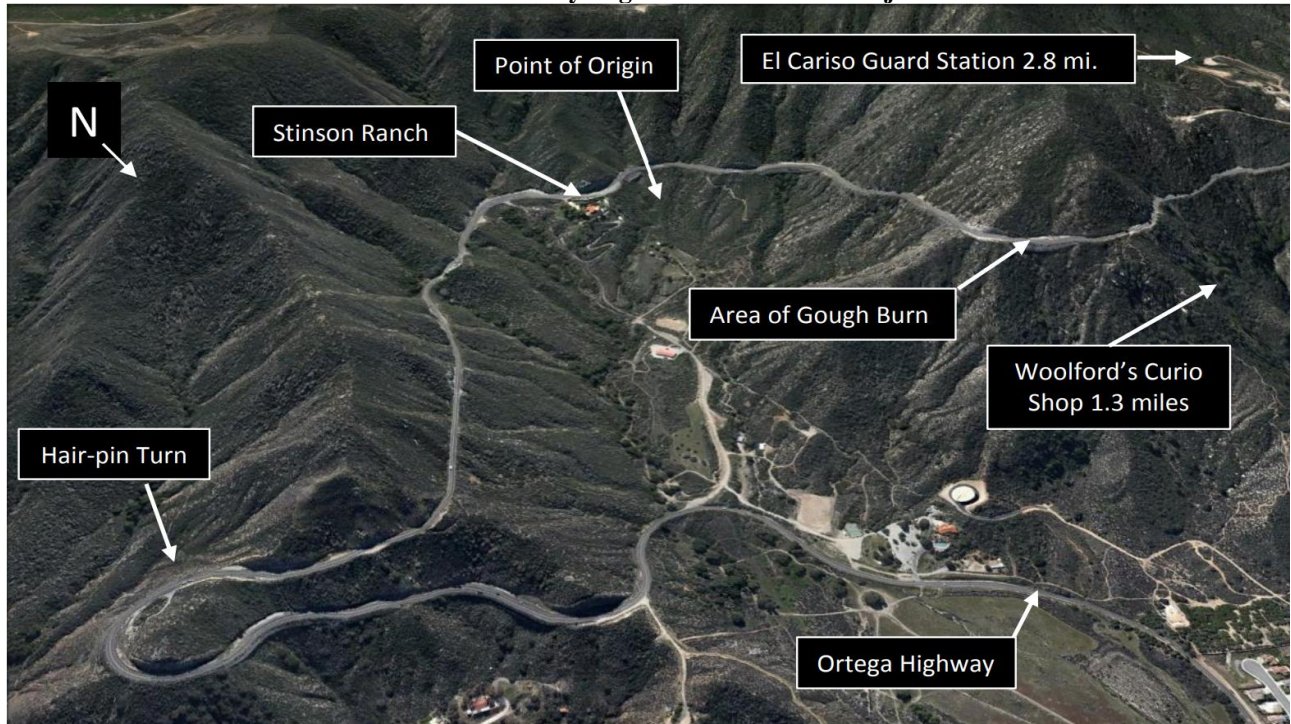
Figure 1. Google Earth satellite image of the mouth of Decker Canyon showing the fire's point of origin and the location of features mentioned in the text.

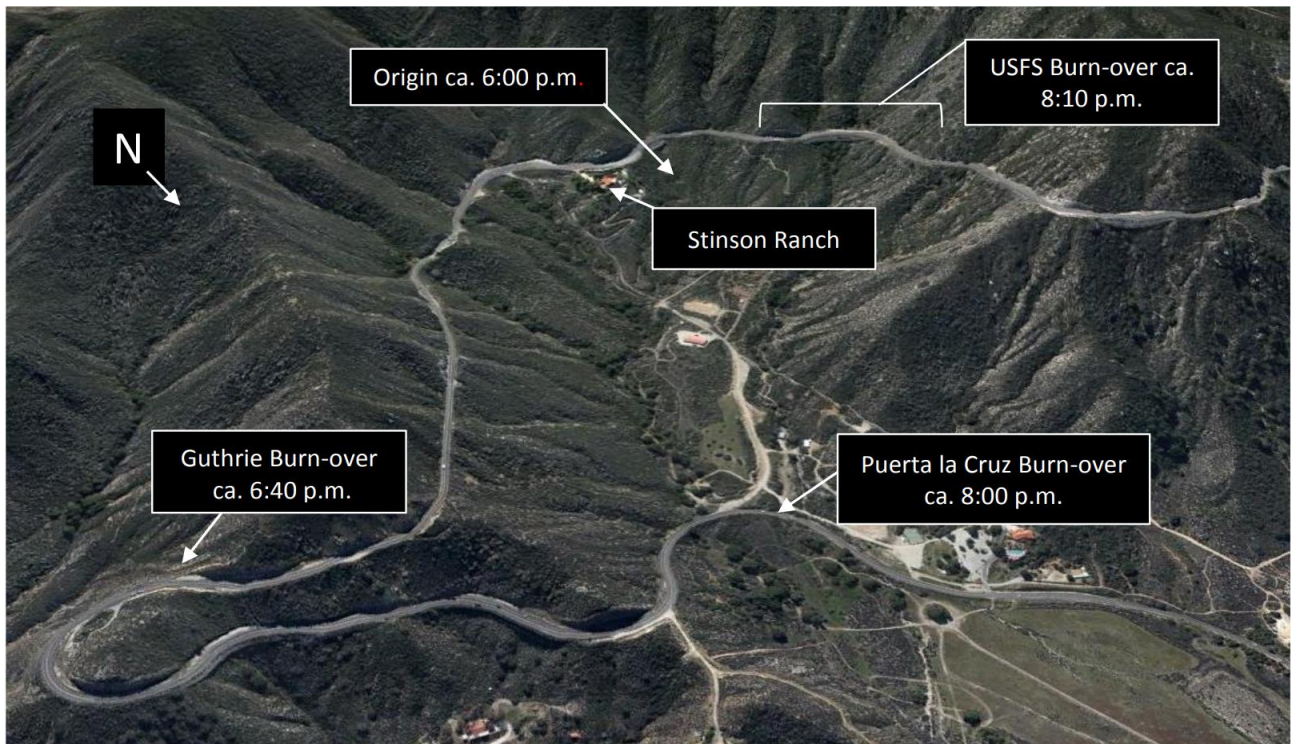
Figure 2. Google Earth satellite image of the mouth of Decker Canyon showing approximate location and timing of the fire's origin and the three burn-over events.
