Incident Summary Page for the 100 Fires Project

Incident Name: Ferguson Fire	Incident Date & Time: 07/29/2018 @ 09:21
Incident Location: Sierra National Forest near Yosemite National Park, California	Incident Size 53,657 acres
Types of resources involved: National Park Service Interagency Hotshot Crew	# of Fatalities/injuries: 1 fatality
Reason this fire was selected for the 100 Fires list: ➤ Hotshot line of duty death	
Conditions leading up to the event:	
<p>The Arrowhead IHC was assigned the Ferguson Fire in July of 2018. Prior to the day of the accident, the Arrowhead crew had worked 12 shifts on the fire and the Superintendent was assigned to another incident position and not with the crew. On July 29, the crew attended the morning briefings at Badger Camp in Yosemite National Park. They were tasked with improving and snagging a partially completed line on Division G, which was the northeast flank of the fire near the Yosemite NP/Sierra NF boundary. On the shift prior to the accident, Acting Arrowhead Superintendent Brian Hughes and a Squad Leader from another hotshot crew working on Division G had scouted this section of line and had identified a number of snags which needed

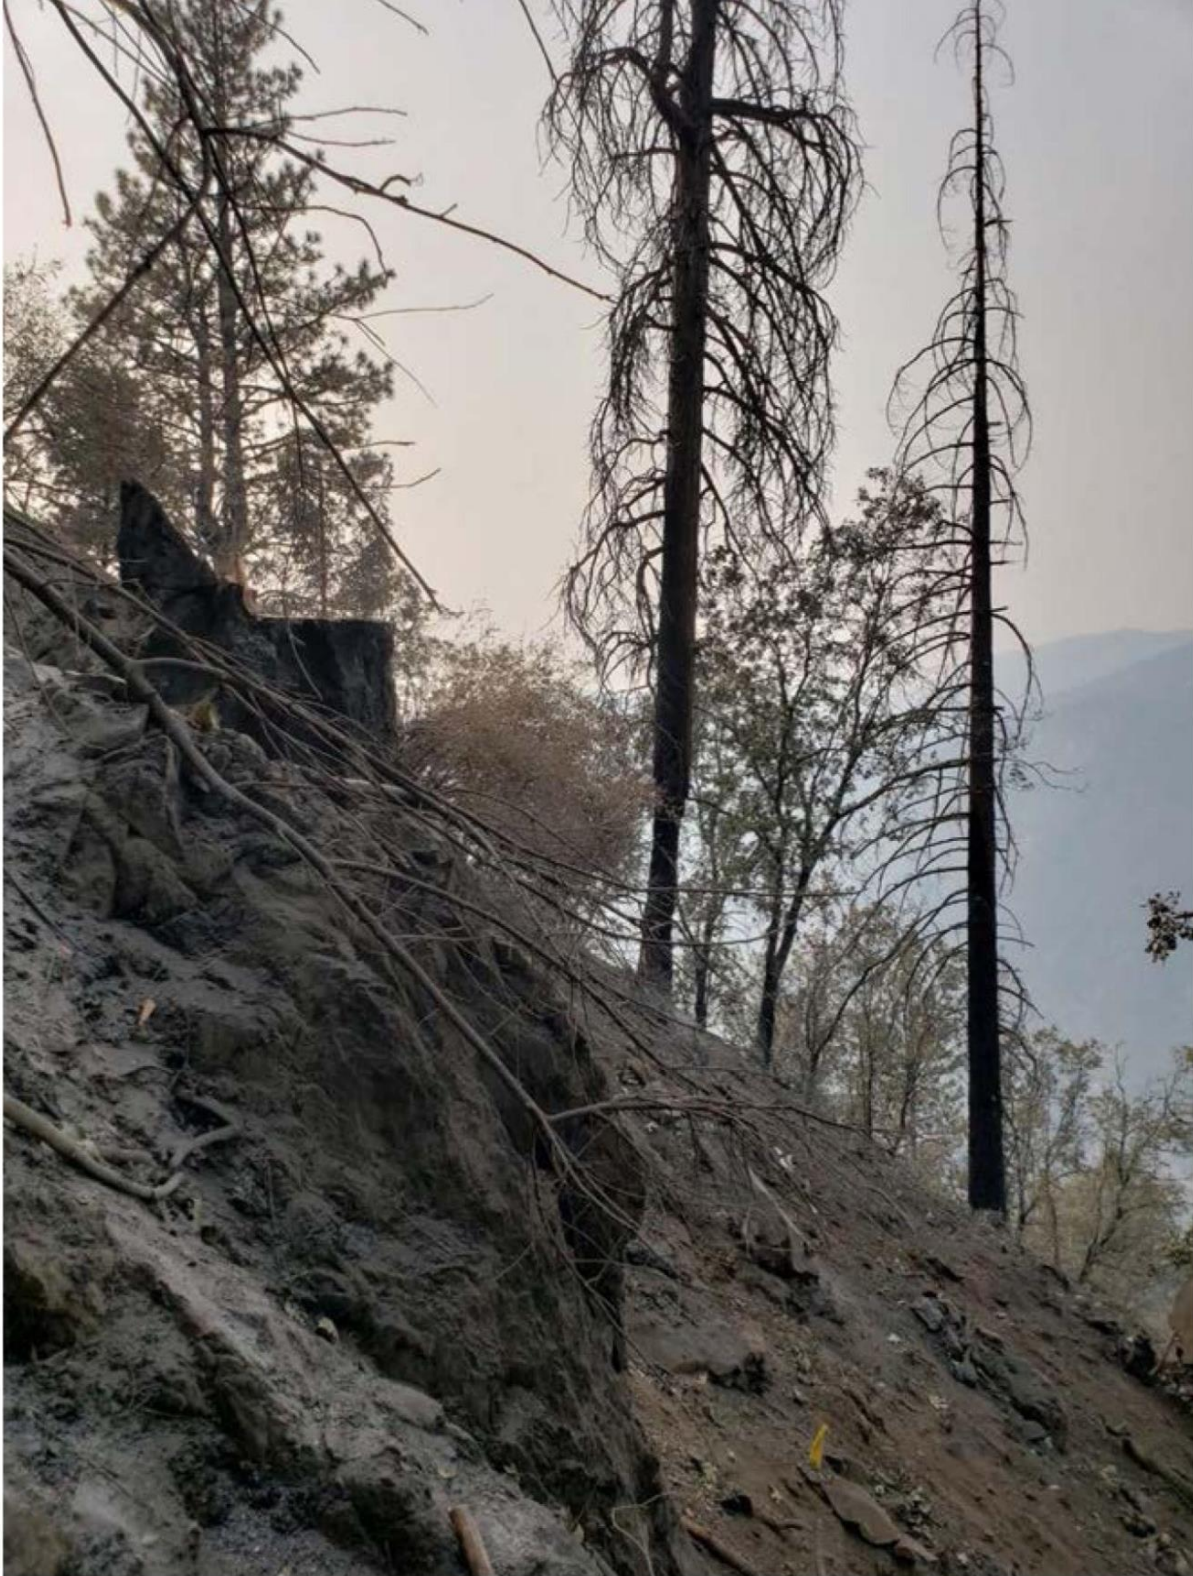
Further stump analysis showed a sloping back cut with a maximum depth of two inches below the face cut. In addition, the offside holding wood was damaged and within an old fire scar. If stump shot is lost for the holding wood from a low back cut, be aware this increases the likelihood that the tree may not fall down the intended direction.

Figure 4: Cutting area showing slope and terrain. Pie wedge was re-placed on the stump

A tree that remains standing after all the cuts are completed indicates there are factors within the tree which were not accounted for in the initial size-up. In instances such as these, pulling back from the tree and doing a complete reassessment of the falling operation is warranted. Walking away from the tree, clearing the area of personnel, posting guards to ensure no one enters the area, and waiting for the tree to fall of its own accord should be viewed as a viable alternative.

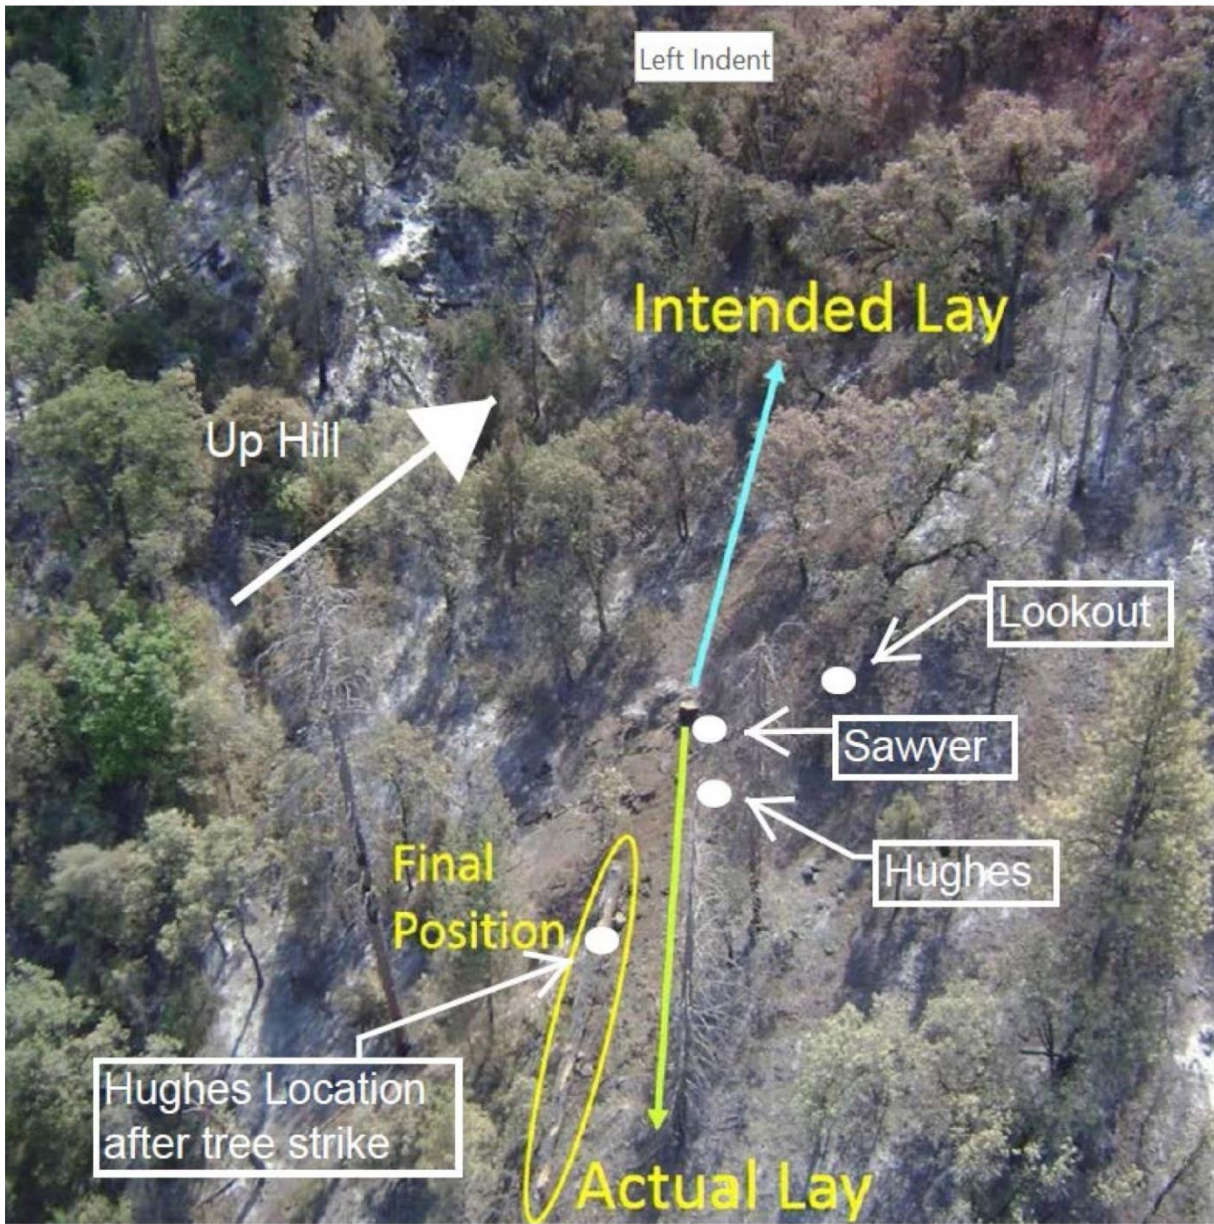
Figure 16: Aerial photograph of the accident site depicting the original location of the snag, the intended lay, and the actual lay and its final position.

When a tree begins to fall, take a moment to look up and determine the direction of fall before moving to safety.
