Incident Summary Page for the 100 Fires Project

Incident Name: Twisp River Fire	Incident Date & Time: 08/19/2015 @ 15:00
Incident Location: Twisp River Road, 5 miles west of Twisp, Washington	Incident Size: 11,922 final acreage 50+ acres at time of entrapment
Types of resources involved: US Forest Service Type 6 engine and Washington Department of Natural Resources heavy equipment group	# of Fatalities/injuries: 3 fatalities / 1 critically burned 3 deployed fire shelters with minor injuries
Reason this fire was selected for the 100 Fires list: ➤ 3 or more firefighter fatalities by entrapment	
Conditions leading up to the event:	
<p>The Twisp River Fire started at 2600 foot elevation along Twisp River Road approximately five miles west of Twisp, Washington. The Twisp River drainage is a major west-to-east drainage running from the Cascade Crest out into the Methow Valley in north central Washington.</p> <p>The area was classified in “extreme drought” and was snow-free by May. The average temperatures in the area were the warmest on record since 1895. The August 19 forecast for the local fire weather zone called for maximum valley temperatures of 89°-95°; minimum relative humidity o

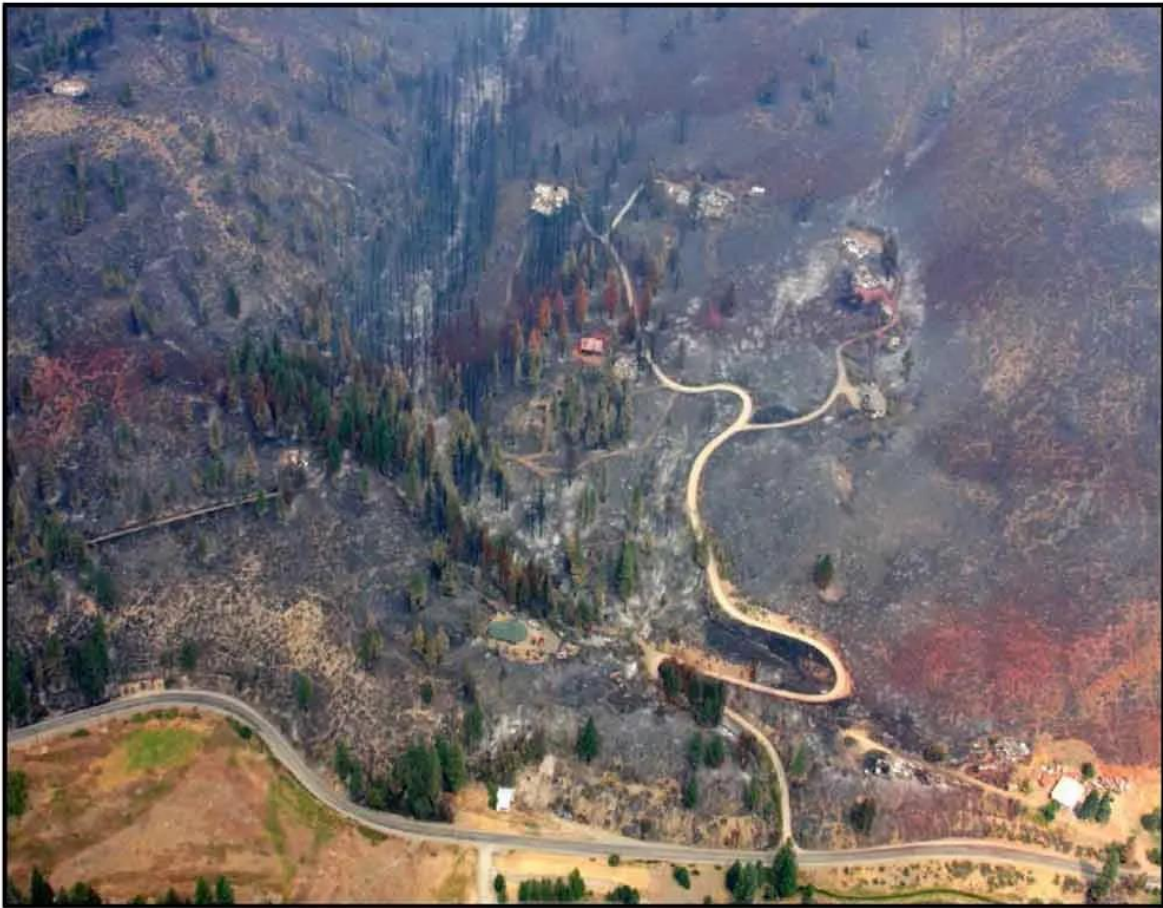
Figure 8—A photo of the post fire scene (paved road is Twisp River Road and the dirt road is Woods Canyon Road).

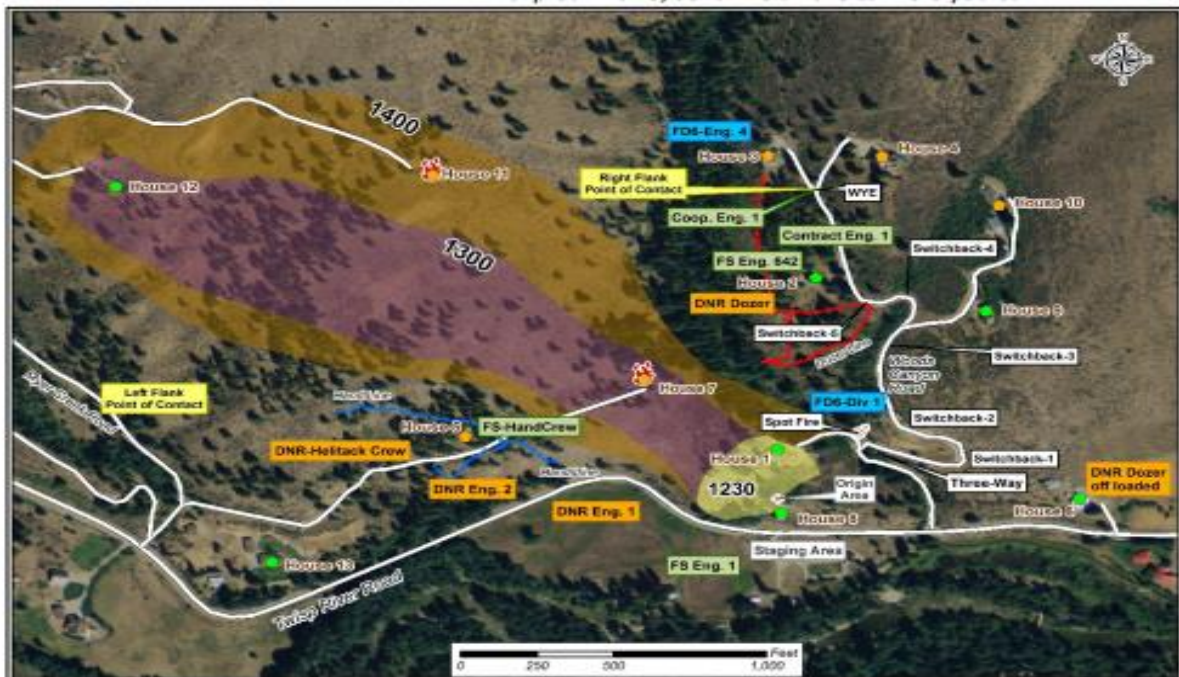
Figure 8: This map shows the Twisp River Fire area with approximate resource locations prior to the wind shift. Orange houses were burned in the fire; green houses survived.

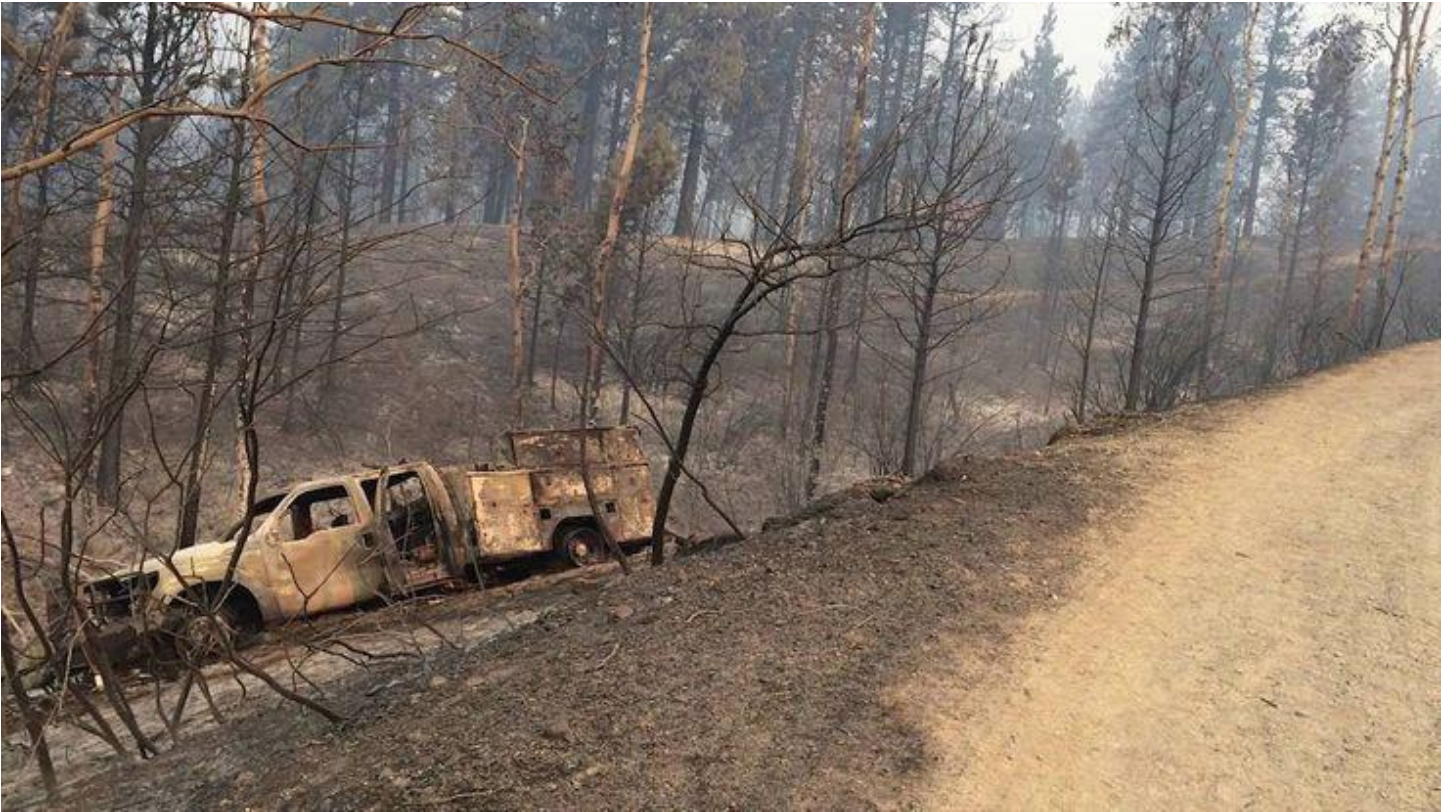
At 15:08 after the wind shift and blow up, the FS IC ordered all resources to disengage and return to Twisp River Road. The FS IC and the right flank POC then began the search for FS Engine-642 and the DNR Dozer Group. After things cooled down a bit they drove up Woods Canyon Road and saw fire shelters, they were relieved when the all three individuals from the Dozer Group emerged. Returning down the road they noticed skid marks and spotted FS Engine-642 off the right side of the embankment, there were no survivors.

Final location of Engine 642

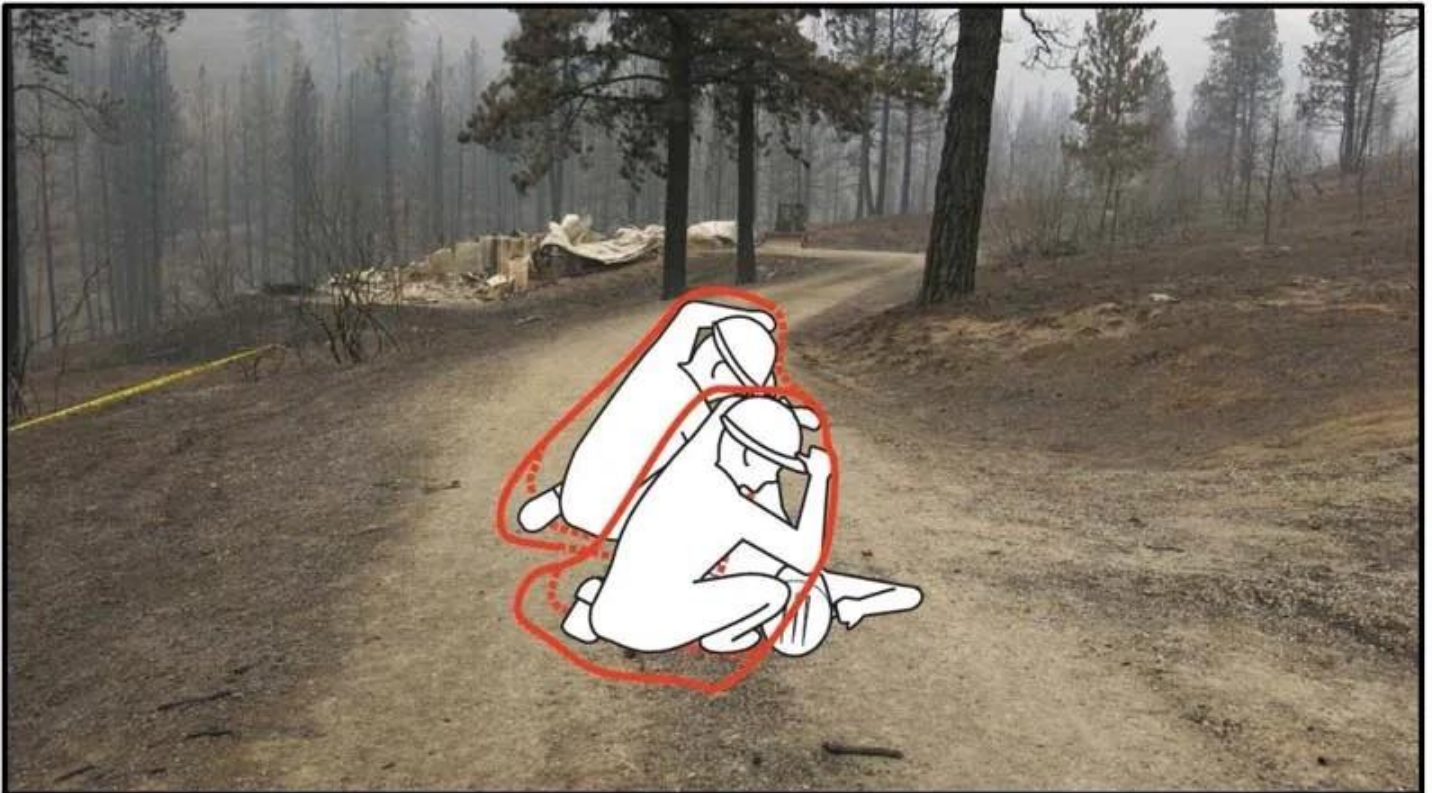
The right flank DNR Dozer Group (dozer operator, Heavy Equipment Boss, and trainee) along with an OCFD Engine were at a house #3 at the upper end of the right flank. The Dozer Group huddled between the dozer and the garage hoping to ride it out, but as conditions got too hot they took refuge in the garage. The OCFD Engine sprayed water attempting to cool the area around the house and garage and dozer. As the fire front passed the garage and house were on fire, the engine saw an opening and proceeded down the road. With the garage now on fire and roof collapsing the Dozer Group left the garage, ran down the driveway to Woods Canyon Road and deployed fire shelters. The dozer operator had left his fire shelter on the dozer, the three shared two shelters. In direct communication with Air Attack, the Heavy Equipment Boss requested and received retardant drops that had a significant effect on reducing the amount of heat.

Figure 7—A depiction of how the dozer group was oriented while in the two shelters. The remnants of house 3 and dozer are in the background of the photo.
