Incident Summary Page for the 100 Fires Project

Incident Name: Twisp Fire	Incident Date & Time: 09/29/2015 @ 15:00
Incident Location:	Incident Size:
Twisp River Road, 5 miles west of Twisp, Washington	50+ acres at time of accident
	11,922 final acreage
Types of resources involved:	# of Fatalities/injuries:
US Forest Service Type 6 engine and Washington Department of	3 fatalities / 1 critically burned / 3 deployed fire shelters with minor
Natural Resources heavy equipment group	injuries
Reason this fire was selected for the 100 Fires list:> 3 or more firefighter fatalities by entrapment

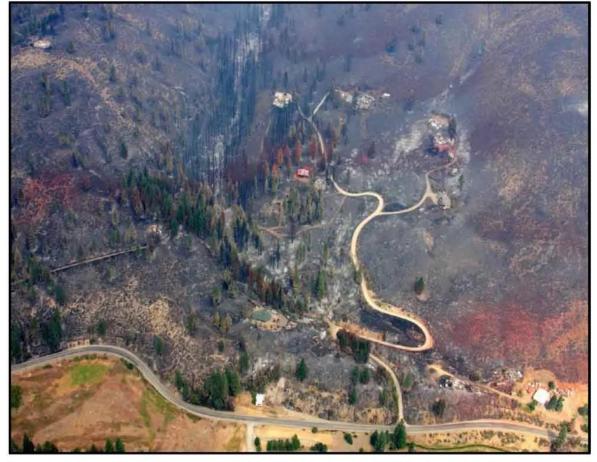
Figure 8—A photo of the post fire scene (paved road is Twisp River Road and the dirt road is Woods Canyon Road).

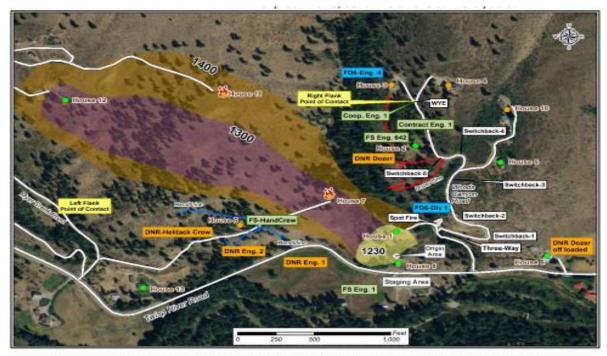
Figure 8: This map shows the Twisp River Fire area with approximate resource locations prior to the wind shift. Orange houses were burned in the fire; green houses survived.

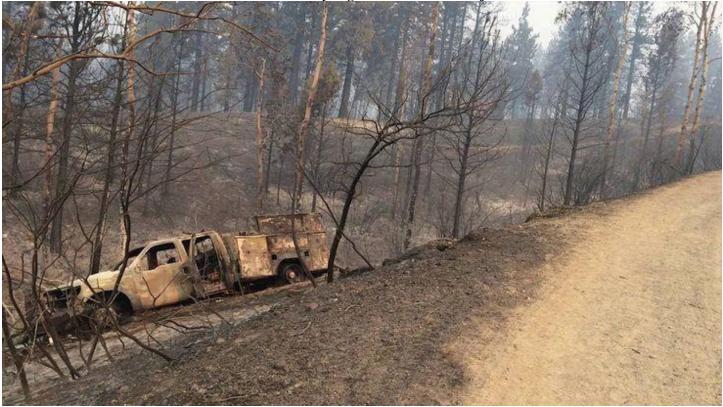
At 15:08 after the wind shift and blow up, the FS IC ordered all resources to disengage and return to Twisp River Road. The FS IC and the right flank POC then began the search for FS Engine-642 and the DNR Dozer Group. After things cooled down a bit they drove up Woods Canyon Road and saw fire shelters, they were relieved when the all three individuals from the Dozer Group emerged. Returning down the road they noticed skid marks and spotted FS Engine-642 off the right side of the embankment, there were no survivors.

Final location of Engine 642

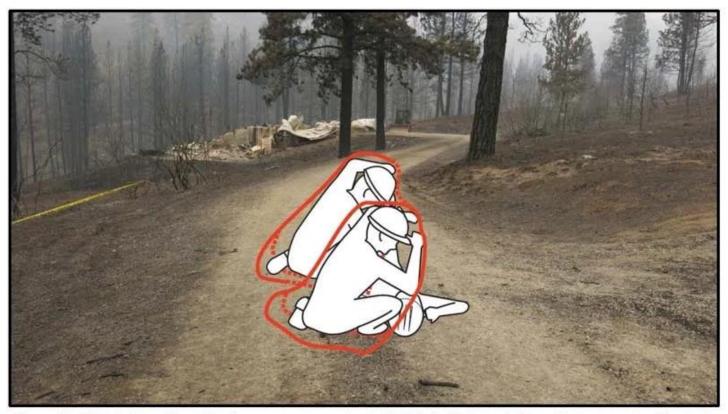
The right flank DNR Dozer Group (dozer operator, Heavy Equipment Boss, and trainee) along with an OCFD Engine were at a house #3 at the upper end of the right flank. The Dozer Group huddled between the dozer and the garage hoping to ride it out, but as conditions got too hot they took refuge in the garage. The OCFD Engine sprayed water attempting to cool the area around the house and garage and dozer. As the fire front passed the garage and house were on fire, the engine saw an opening and proceeded down the road. With the garage now on fire and roof collapsing the Dozer Group left the garage, ran down the driveway to Woods Canyon Road and deployed fire shelters. The dozer operator had left his fire shelter on the dozer, the three shared two shelters. In direct communication with Air Attack, the Heavy Equipment Boss requested and received retardant drops that had a significant effect on reducing the amount of heat.

Figure 7—A depiction of how the dozer group was oriented while in the two shelters. The remnants of house 3 and dozer are in the background of the photo.
