Incident Summary Page for the 100 Fires Project

Incident Name: Sundance Fire	Incident Date & Time: 09/01/1967 @ 16:00
Incident Location: Sundance Mountain, Bonner County, Idaho	Incident Size: 55,910 Acres
Type of resources involved: Heavy equipment and US Forest Service overhead personnel	# of Fatalities/injuries: 2 fatalities
Reason this fire was selected for the 100 Fires list: ➤ Fire made a notable impact within the wildland fire service.	
Conditions leading up to the event:	
By mid-August of 1967, the Selkirk Mountains of Northern Idaho were in moderate drought. The last wetting rain of the area was in June, and conditions had steadily become hotter and drier as the months passed. Fire danger was classified "Extreme" when a lightning bust moved through the area. The primary fuel type of these mountains was thick timber with areas of logging slash. During the lightning bust, many fires were ignited, including the Sundance Fire, which started on Sundance Mountain near Sundance Lookout.

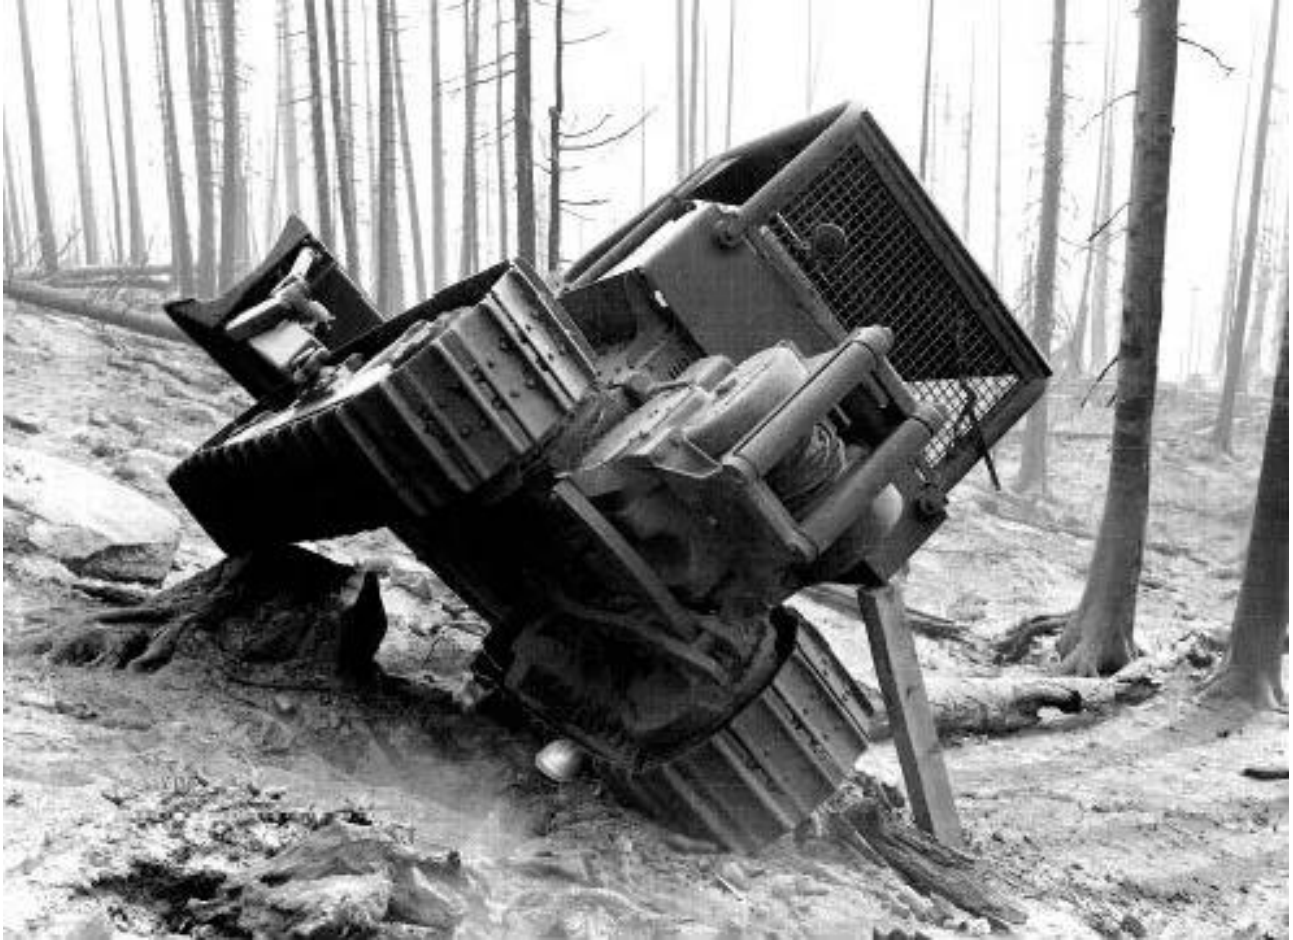
**The dozer after the burn over
(Jim Peterson, Evergreen magazine, 2023)**

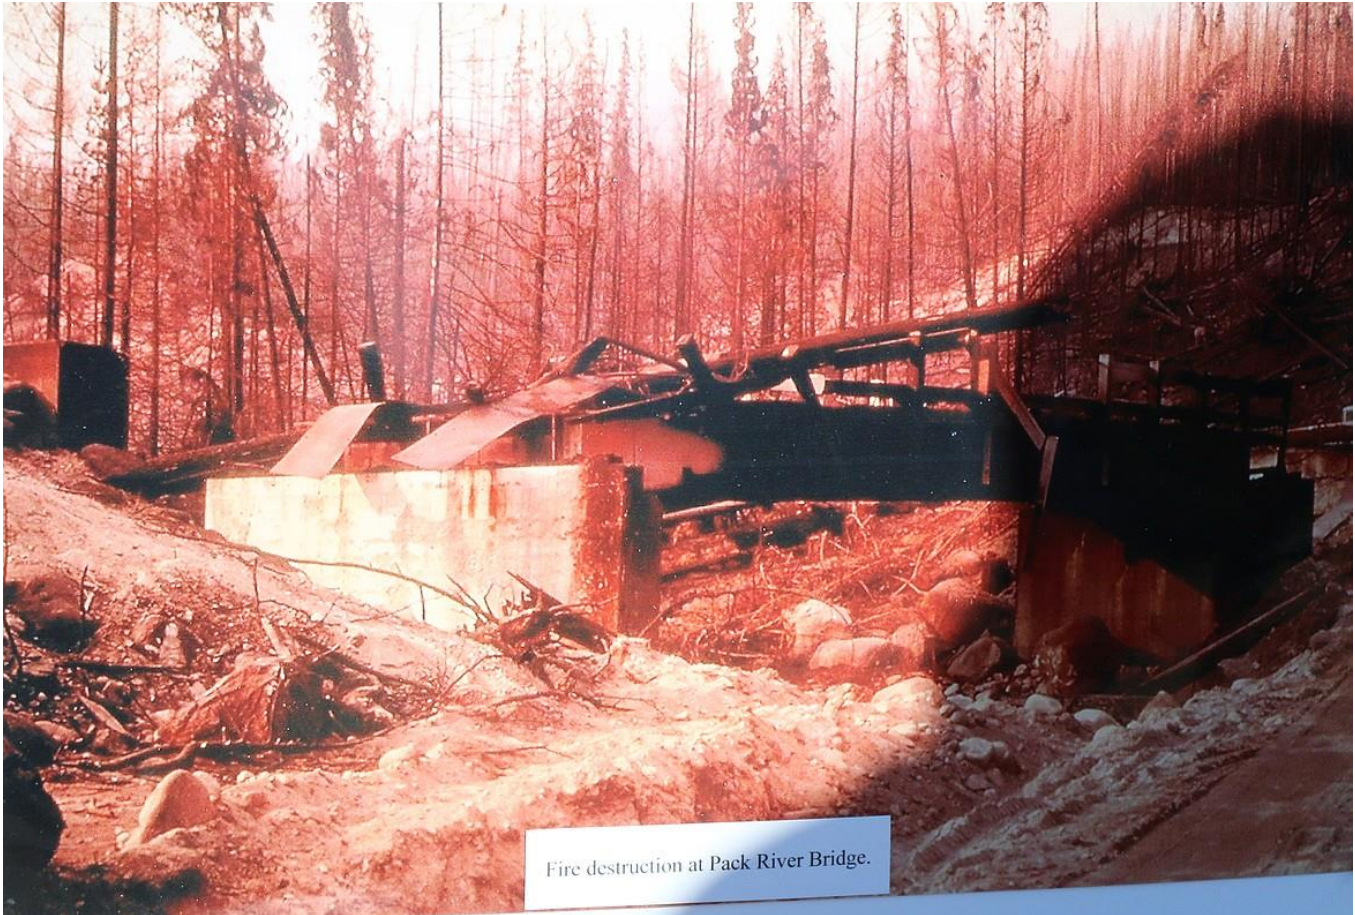
At 11:00 hours, a Dozer Operator and Sector Boss began work moving up the Pack River drainage toward their safety zone on the eastern part of the Selkirk Divide. The safety zone was located at Fault Lake; nearly 4 miles up drainage and 3000 vertical feet above them. By 13:00, only 2 hours into their work shift, strong southwest winds took hold of the fire as it raced eastward, up Soldier Drainage, to the top of the Selkirk Divide. Throughout the afternoon, the fire made large downhill runs on the eastern side of the divide as winds ranged from 30 to 50 mph.	
Both the Sector Boss and Dozer Operator were overtaken in the Pack River drainage at approximately 16:00 where they hid underneath the dozer to shield them from the flames pushing down the river drainage (photo 1). Sadly, both men were found dead on site. Their names were Luther Rodarte and Lee Collins.	
The Sundance Fire moved on to burn ~10 million board feet of lumber spanning 55,910 acres. The fire was so hot in some drainages that it created its own winds strong enough to snap large trees and spot 10 miles ahead of itself. In the Pack River Valley, temperatures reached 1200 °F which caused the steel of the Pack River Bridge to warp (photo 2).

The fire damaged Pack River Bridge

**The US Forest Service research document infers the fire reached 1200°F for the steel to warp under its own weight
(Caroline Lobsinger, Bonner County Daily Bee, 2017)**
