Incident Summary Page for the 100 Fires Project

Incident Name: Decker Fire	Incident Date & Time: 08/08/1959 @ 18:00
Incident Location: Ortega Highway, 3 miles west of Lake Elsinore Village, Riverside County, California	Incident Size: 1391 acres final size
Types of resources involved: US Forest Service Hotshot Crew, tankers, and district personnel California Division of Forestry tankers and inmate crew	# of Fatalities/injuries: 6 fatalities / 12+ injuries Unable to verify exact number of injuries from investigation report
Reasons this fire was selected for the 100 Fires list: <ul style="list-style-type: none"> ➤ Fire is historically significant ➤ 3 or more firefighter fatalities by entrapment 	
Conditions leading up to the event:	
<p>On the day of the incident, a group of teenagers were partying in a campground on the Cleveland National Forest. In the late afternoon, a fight broke out and two of the partiers decided to leave. They headed east on the Ortega Highway towards Elsinore. They lost control of their pick-up on a steep, twisting section of the highway and plunged 200 feet over an embankment and burst into flames, igniting the tinder dry brush. The driver died in the acciden

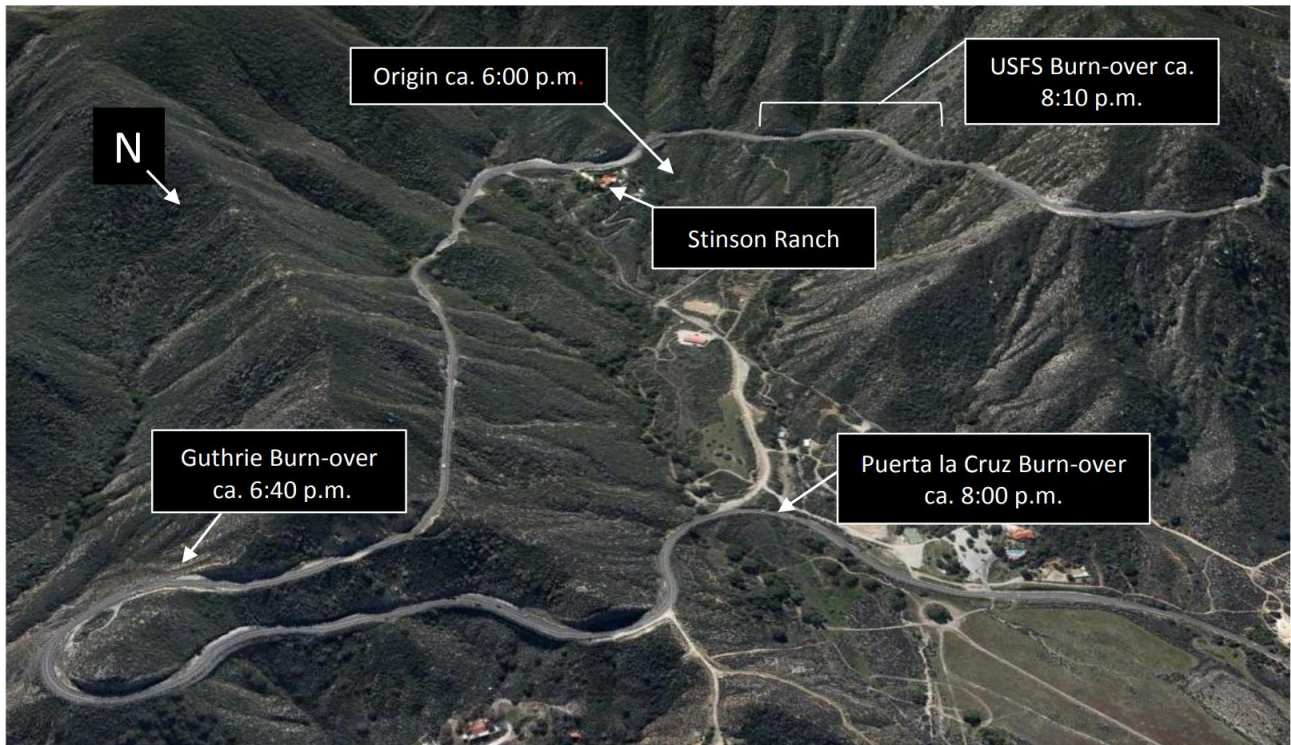
Brief description of the event:	
<p>There were three burn-over incidents within the first two hours of fire suppression actions:</p> <p>The first incident occurred at 18:40. A California Division of Forestry tanker with a Tanker Foreman and 5-man crew pulled into a turnout along a hairpin turn. The Tanker Foreman exited the cab and went over the embankment to get a better look at the fire burning below. Almost immediately he came scrambling back, yelling for the crew to get in the cab and move the truck. Before they could move the truck, the fire burst upon them and engulfed the truck. Two crewmen received serious burns to the arms and hands while three others received lesser injuries. The Tanker Foreman was burned over 85% of his body, he would later succumb to these critical burns.</p> <p>The second incident occurred at 20:00 in an assembly area (staging) along the Ortega Highway below the fire. The Puerta la Cruz inmate crew were in their 2 ½ ton stake-side truck with a canvas tarp covering the top waiting for an assignment. A California Division of Forestry tanker was parked behind them. The California Division of Forestry Tanker Foremen would later recount “<i>We heard what sounded like a very loud freight train. It looked like a huge dust devil coming down slope straight towards us. It looked like it was 1000 feet across at the base and was moving fast and it was all fire.</i>” The flames engulfed the Puerta la Cruz crew truck, the tarp was burning, and men were screaming and jumping over the sides and out of the back. They were taking cover under the crew truck and running through the nearby field tearing off burning shirts and pants as they ran. The Tanker Foreman and his crew were trapped in the cab of their tanker as the fire burned past and they sustained no injuries. There were numerous burn injuries to the inmates but no fatalities.</p>

The third incident occurred at 20:10 on the upper reaches of the Ortega Highway where the US Forest Service had initiated their initial attack. Resources included the El Cariso Hotshot Crew, several tankers, a Fire Prevention Technician, and the District Ranger who was coordinating suppression activities. Early attempts at direct attack had failed. The decision was made to attempt to hold the fire below the road by firing the road towards the Gough Fire that had burned 3 weeks earlier. There was an urgency to get this done before the wind shifted from downslope to upslope. The resources were split into three groups. The plan was put into action and appeared to be progressing well. A short time later, the wind abated and then switched to upslope. The flames quickly increased in length and made a rapid uphill run engulfing the resources working on the highway. The lower group was able to drive and walk down the highway to safety. The middle group ran through smoke and flames and suffered burn injuries. The upper group was overrun by flames, some in vehicles and others fully exposed, with numerous burn injuries from minor to critical. Five of the firefighters in the upper group would succumb to their critical burns. These included the District Ranger, a Tanker Foreman and three crewmen from the hotshots.

Figure 2. Google Earth satellite image of the mouth of Decker Canyon showing approximate location and timing of the fire's origin and the three burn-over events.
