Incident Summary Page for the 100 Fires Project

Incident Name: Decker Fire	Incident Date & Time: 08/08/1959 @ 18:00
Incident Location: Ortega Highway, 3 miles west of Lake Elsinore Village, Riverside County, California	Incident Size: 1391 acres final size
Types of resources involved: US Forest Service Hotshot Crew, tankers, and district personnel California Division of Forestry tankers and inmate crew	# of Fatalities/injuries: 6 fatalities / 12+ injuries Unable to verify exact number of injuries from investigation report
Reasons this fire was selected for the 100 Fires list: <ul style="list-style-type: none"> ➤ Fire is historically significant ➤ 3 or more firefighter fatalities by entrapment 	
Conditions leading up to the event:	
<p>On the day of the incident, a group of teenagers were partying in a campground on the Cleveland National Forest. In the late afternoon, a fight broke out and two of the partiers decided to leave. They headed east on the Ortega Highway towards Elsinore. They lost control of their pick-up on a steep, twisting section of the highway and plunged 200 feet over an embankment and burst into flames, igniting the tinder dry brush. The driver died in the acciden

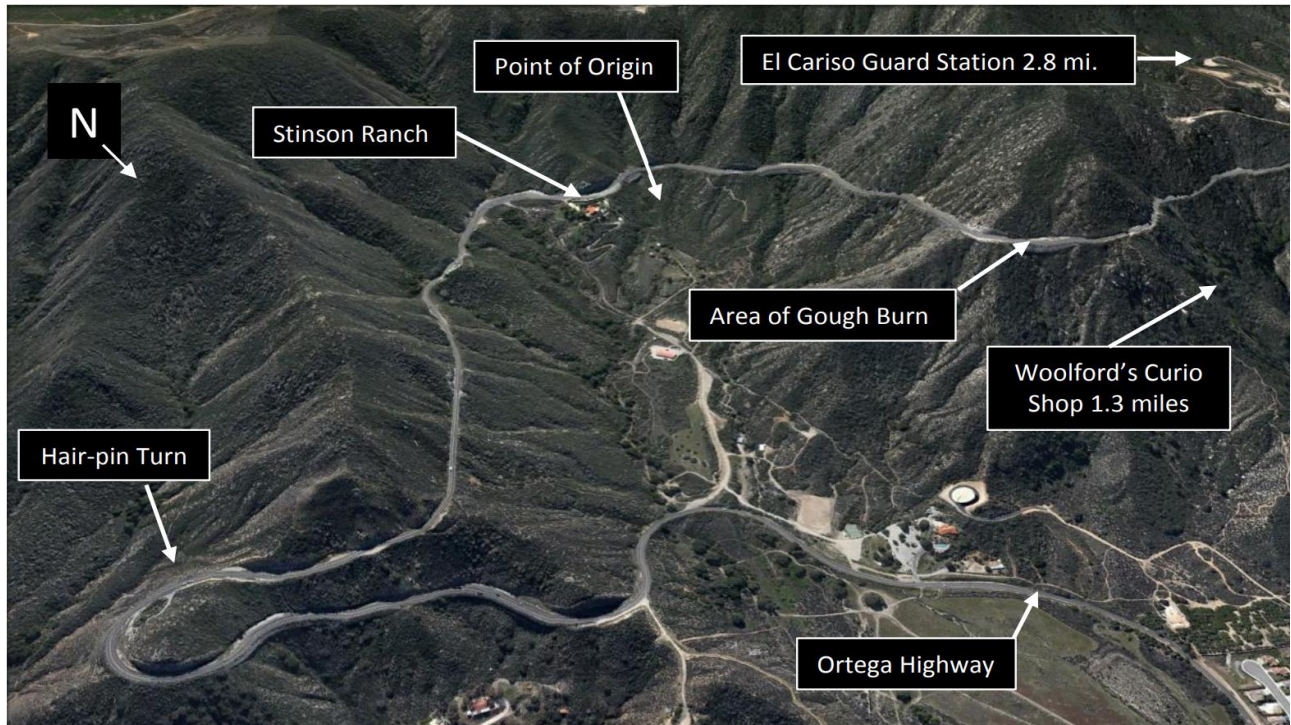
Figure 1. Google Earth satellite image of the mouth of Decker Canyon showing the fire's point of origin and the location of features mentioned in the text.
